National Transportation Safety Board Survival Factual Report

Survival Factual

Date of Accident: October 2, 2005
NTSB#: DCA06MM001
Accident: Capsizing and subsequent sinking of the N.Y.State certified
Public vessel *Ethan Allen*
Location: Lake George, New York near Cramer Point

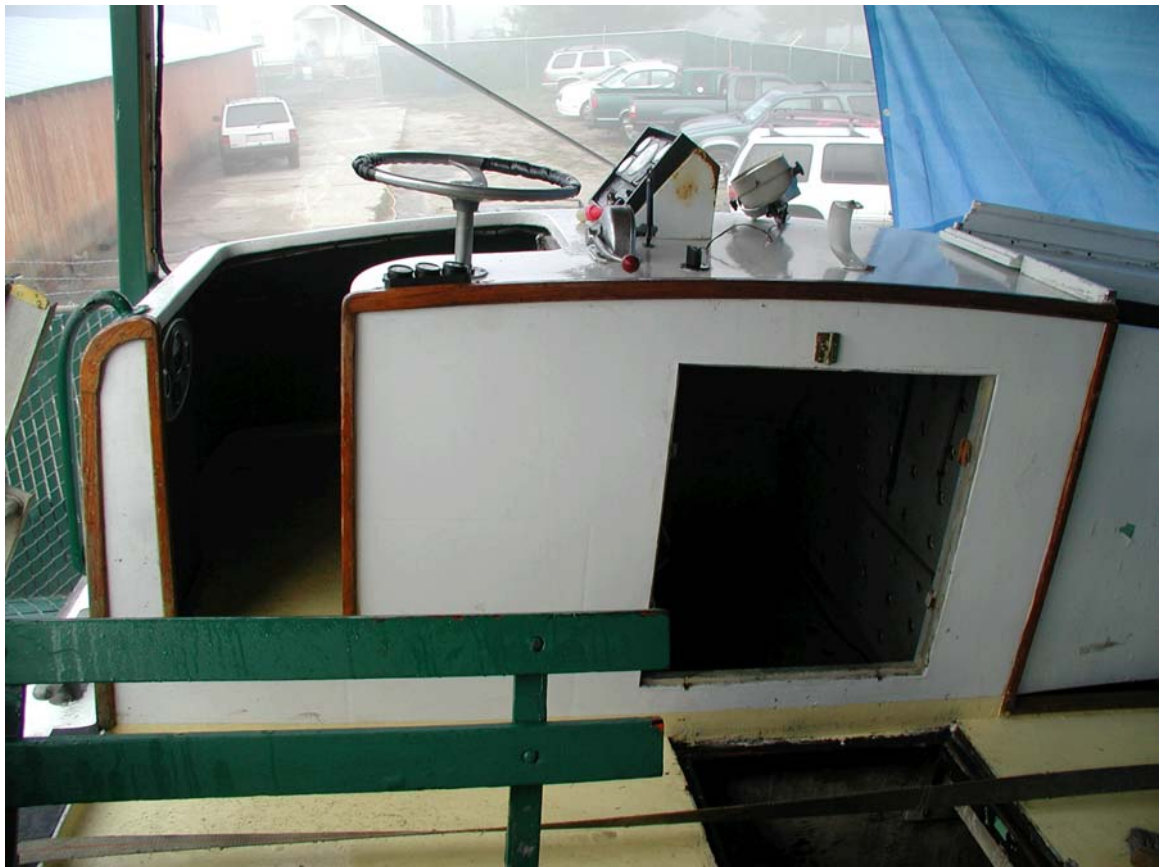
The adult lifejackets were stowed in an aft cabinet adjacent to the operator's station, with latched door at the centerline of the vessel.

The captain's operating station was at the far aft starboard stern area of the vessel. It was accessible with an open entry measuring 30 inches in width. The boarding area the day of the accident was located on the port side and defined with an open entry of 30 inches in width.

Photo shows captain's station, starboard entry and the adult lifejacket location.

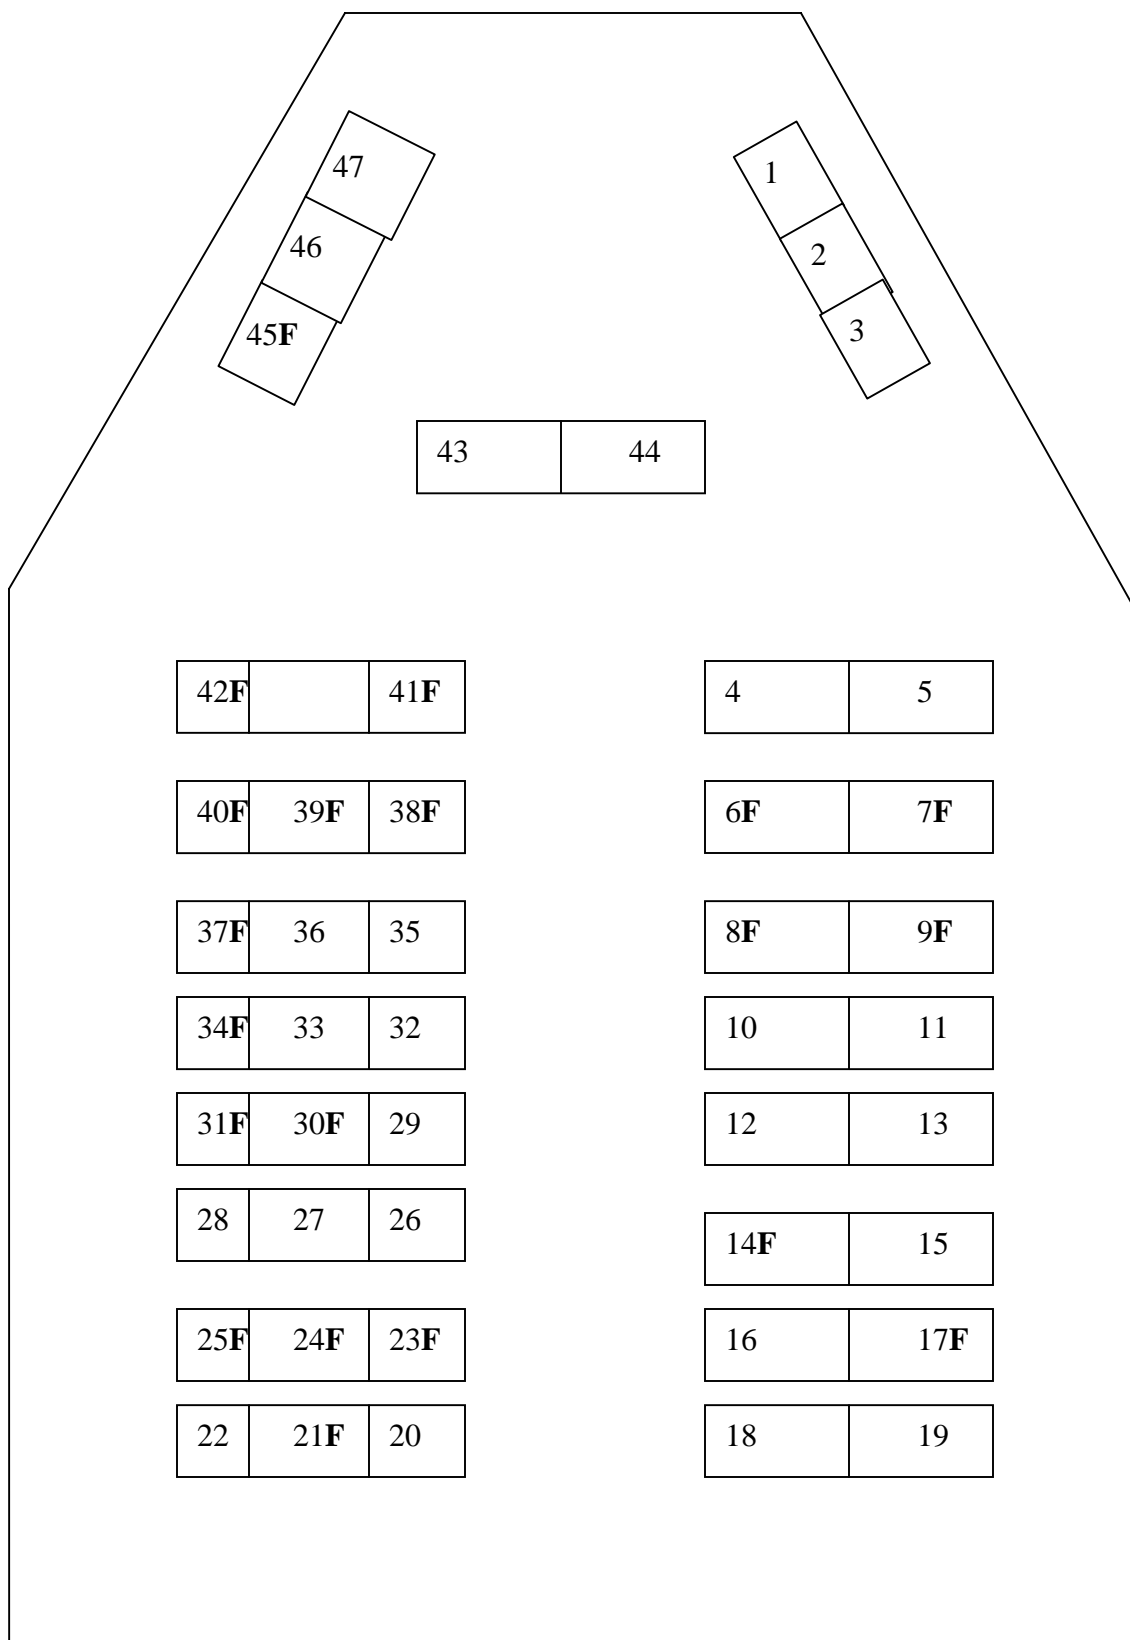
1 According to survivor accounts, the fatality victims were not seated in any one
2 particular area of the vessel. The victims were on both the port and starboard sides of the
3 vessel and seated in either window or aisle seats before the capsizing.

1 The following illustration shows the seating arrangement of the passengers and
2 where the fatalities were sitting prior to capsizing, along with a table showing the
3 passengers sex, age, weight, height and body mass index (BMI).
4
